If you have print quality problems, clean the corona wire following the steps below:

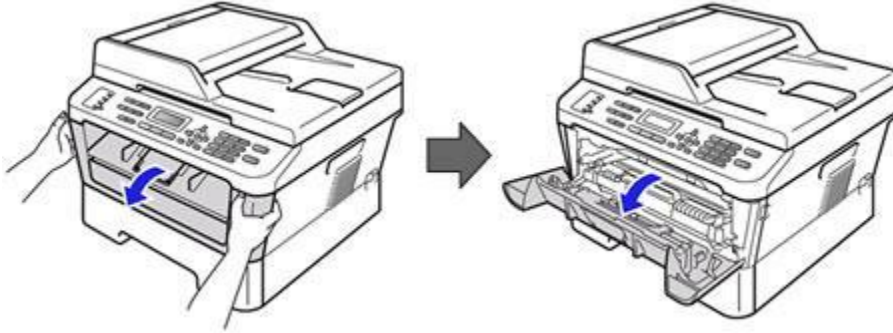
1. Open the front cover and leave the machine turned on for 10 minutes to cool

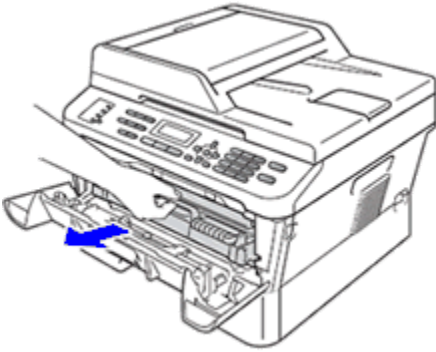
2. Slowly take out the drum unit and toner cartridge assembly.

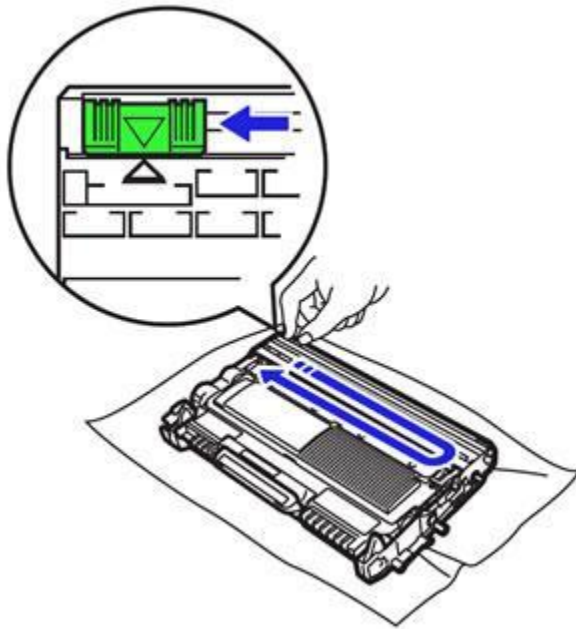
3. Clean the corona wire inside the drum unit by gently sliding the green tab from left to right and right to left several times.
